ACCESS TO THE ENVIRONMENT

**A Series of Reference Documents on the Design and
Development of Site Facilities to Make Them
Barrier Free to the Physically Handicapped and Disabled**

Case Studies of Barrier Free Sites

American Society of Landscape Architects Foundation

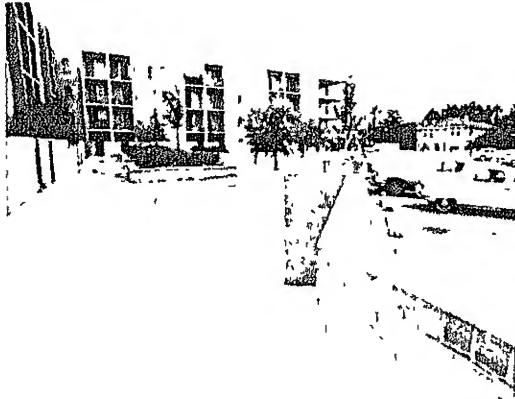
VILLA TRANCHESE San Antonio, Texas

Villa Tranchese is located on a large site which is well planted and well maintained. The site is close to nearby shopping and all of the curbs surrounding the site have either dropped curbs or curb cuts in order to provide easy access for the residents from the site to the surrounding areas. There are two parking lots on the site. The one in the front is smaller, largely used for visitor parking, and the one in the rear is larger, used primarily by the residents of the building. The service to the site is at the rear of the building and does not interfere in any way with the movement of the residents into the building.

This particular housing for the handicapped and elderly seems to conform very clearly in site design to the San Antonio formula. There is a covered canopy over the entrance walk which is of cast-in place concrete, supported by four concrete columns. On either side of these columns is an upright support to give stability to the railings. There is a dropped curb which is discontinued at the entrance, giving easy access between the entrance drive and the entrance walk. In this particular case there is also an enlarged entry platform on either side of the entrance walk adjacent to the driveway walk. There is also, in this case, a vine covered wall surrounding a court which is paved and which provides outdoor sitting and recreation area for use by the building residents. Inside this court are benches, tables, and other outdoor recreational facilities.

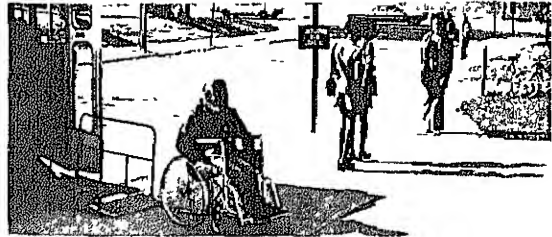
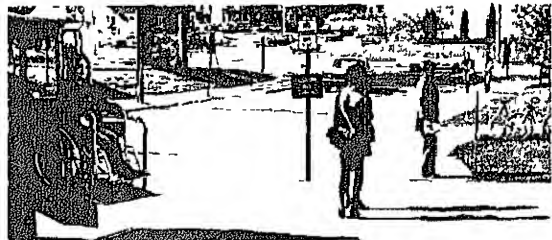
A bus system for the handicapped runs throughout the campus. Buses are equipped with forklifts which will pick up students in wheelchairs at the curb and lift them into the bus.

At each bus stop, an extra lane allows the bus to pull out of traffic to allow time to load and unload without impeding traffic. All stops are marked by signs indicating "handicapped bus loading." Photographs show a student in a wheelchair being unloaded from a bus.

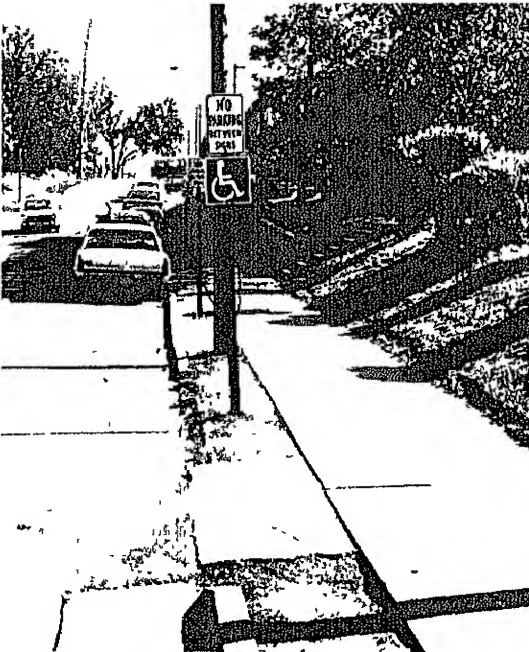
Yellow lines and yellow arrows are used to indicate appropriate points for crossing grade changes and traffic routes. All dropped curbs are marked by this yellow painted arrow point

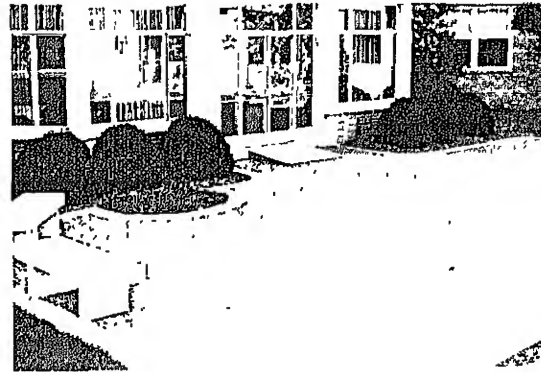
In some cases, simple temporary wooden ramps were used. In other cases, a complex system of ramps was built at considerable cost

Photographs show some of the entries made accessible.

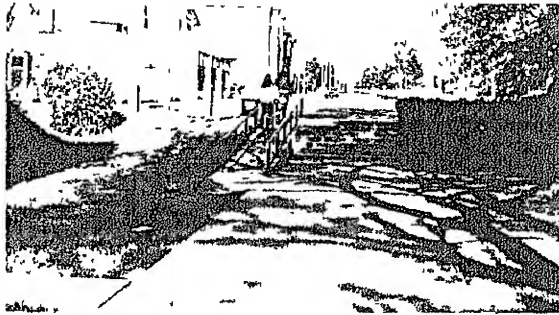
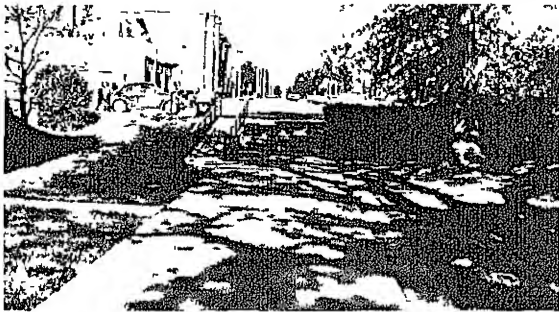
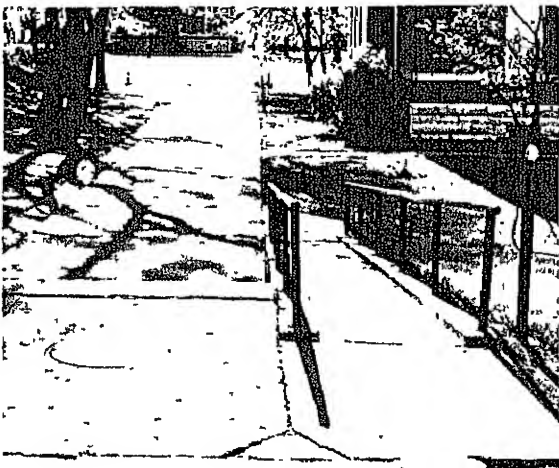
Curb cuts or curb alterations have been made throughout the campus. Essentially two forms of curb cut have been used. One is a straight curb cut with ramping, the other is an offset dropped curb and ramp. Photographs show several varieties.

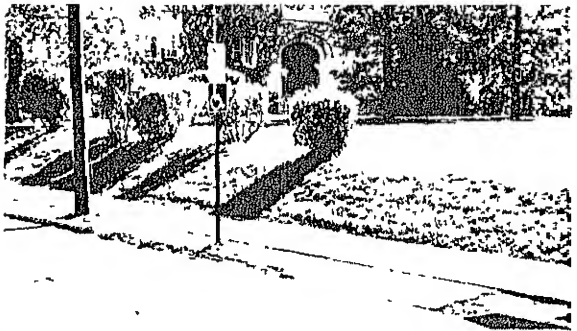
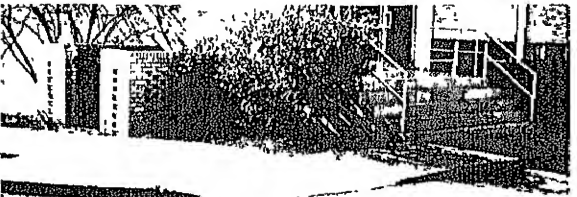
Sidewalks and other pathways throughout the campus have been made passable for the handicapped. Permanent ramps may be either integral or additive, temporary ramps may be stationary or portable.

It should be noted that the ramps have made all pathways easier to traverse by bicycle. This has both positive and negative aspects - while serving a large number of students, a conflict is created between the various wheeled vehicles - the slow wheelchair and the much faster bicycle.

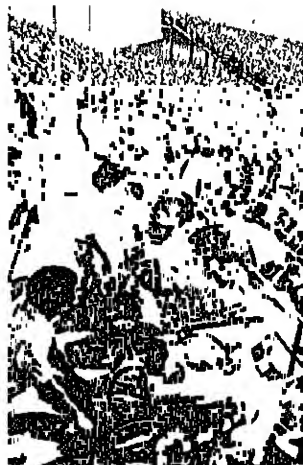
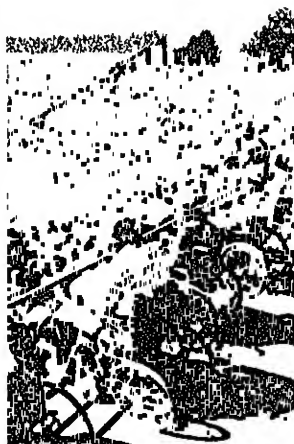
END VIEW
SCALE 1/4" = 1'
TYPICAL SECTION OF STAND

The football stadium at the University of Missouri has been adapted to make it possible for persons in wheelchairs to be pushed up ramps into the stadium and placed in a specially redesigned and constructed area immediately adjacent to the scoreboard.

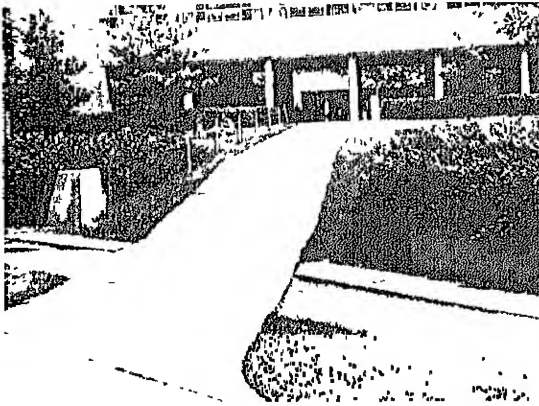
A transportation system of specially designed buses serves the handicapped throughout the campus. The standard type bus is modified by removing most of the seats, leaving an open space for wheelchairs. At the front door to the bus a special lift is constructed. As the bus pulls up to a curb the doors open and a hydraulic platform moves out and down until it rests flat on the sidewalk. A wheelchair is rolled onto the platform, locked into place, and is then raised up and into the bus.

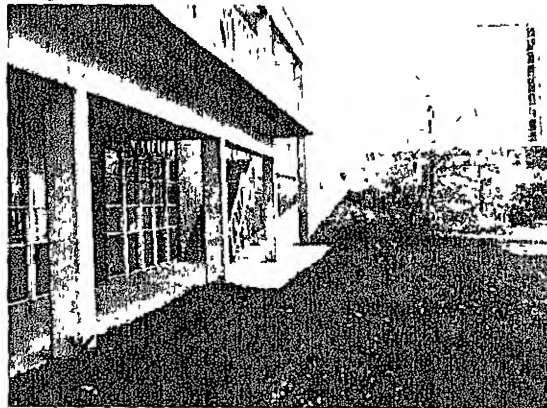
Exposed aggregate finish is used on some of the ramps to provide a non-slip surface and to indicate a change in direction or level.

Whenever there is a grade change a person has a choice to either use a ramp or stairs. The ramps are designed as an integral part of the stairs or structure.

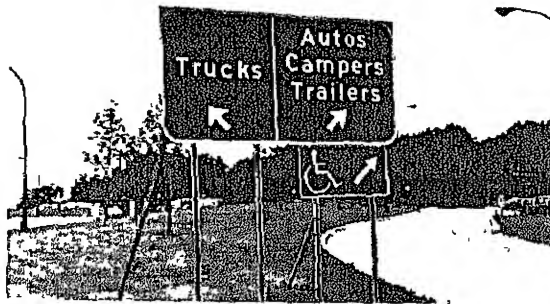
After turning off the interstate, the directional sign indicating which way to go also displays the international symbol. Directly in front of the rest room building a curb cut has been provided. The visitor can then travel on a concrete walk to the entrance. The entrance doors to both the men's and women's sides are full length glass with a flush threshold. One toilet stall has been made wider and provided with horizontal grab bars and outward swinging door. The room is large and spacious and allows for easy maneuverability for a wheelchair. Picnic shelters have been provided around the rest room building. Each shelter has an asphalt paved walk leading to it. The tables are concrete and can accommodate a wheelchair at each end.

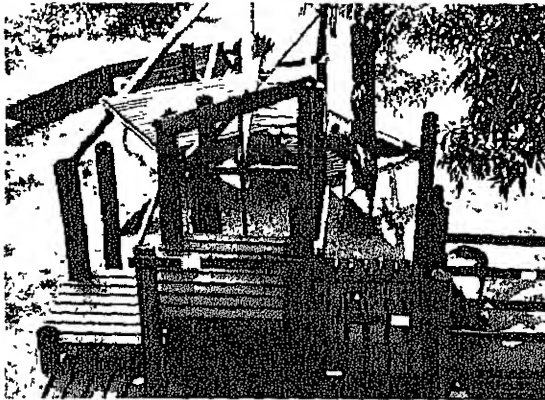
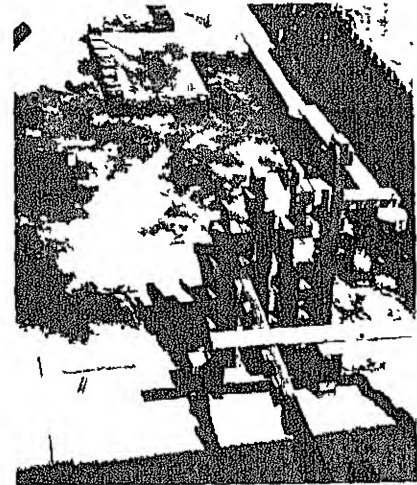
The playground is enclosed by a wire fence and is adjacent to the school building. It is broken up into five basic areas, each area having a specific type of activity. The first area consists of a wooden play structure made from a series of poles and platforms of varying elevations. As the child works himself up from one platform to another, he eventually gains the top where he can either slide down a fireman's pole or work himself hand over hand across a ladder to another platform and a ride down a slide. The structure is painted with various shapes of different colors, a teaching carryover from the classroom.

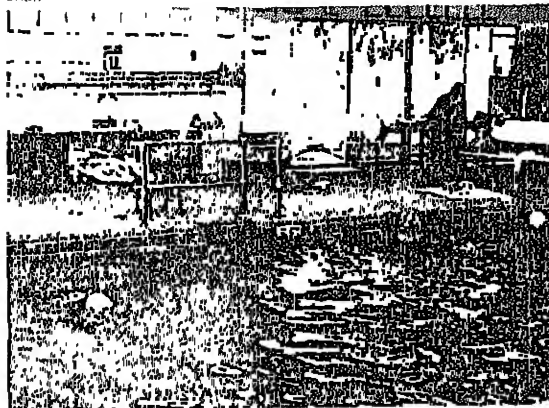
Swim Center

Provisions for the physically handicapped have been made in the swim center. A wheelchair ramp allows wheelchairs down into the water. Broad shallow training steps in the shallow end enable gradual entrance into the water. Along the edge at several points, resting ledges, treading steps and teaching corners provide needed assistance in teaching the handicapped how to swim. The deck is radiantantly heated and the air temperature is maintained at 86 degrees. Dressing rooms and showers accommodate the wheelchair.

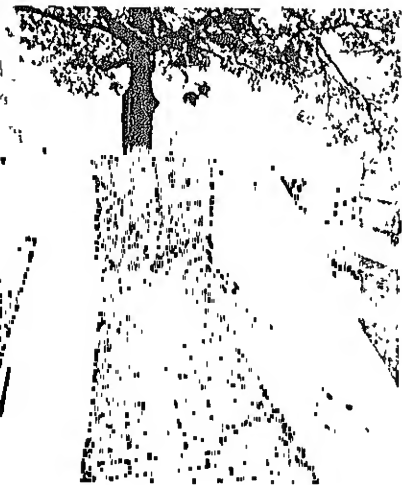
"To satisfy this desire, to give dignity to this type of motivation, required the design of a tree house that was functional for our exceptional children with their limited mobility and restricted motion. We believed that we had an opportunity to motivate children to walk if we could create a place to which they wanted to go. If our thinking was correct - that young handicapped children would be equally intrigued by treehouses - the design of this outdoor structure with modified approaches and exits would be the very incentive needed to foster and enhance their mobility and ambulation."

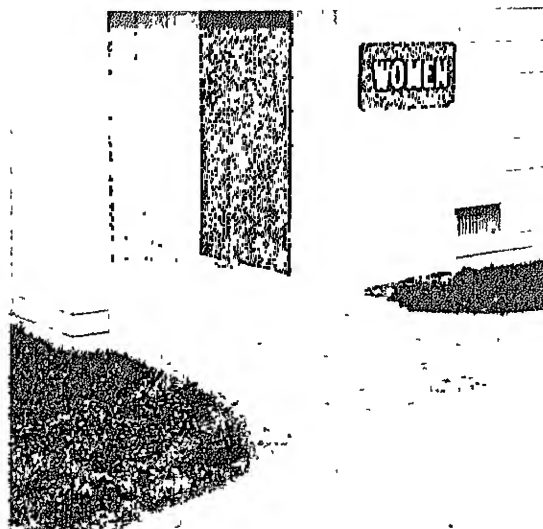
from the floor. This permits easy transfer from a wheelchair. Around the perimeter of the toilet stall are grab bars to assist in the transfer from the wheelchair. These grab bars are also located around the wash basins and in the dressing rooms. Four benches within each dressing room are twenty-four inches wide to permit a handicapped person to lie down so that, if necessary, an attendant may dress him for swimming.

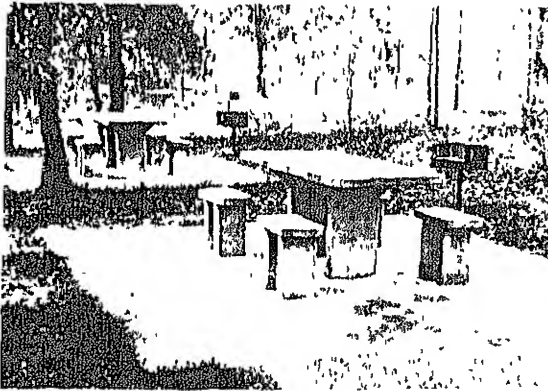
he tops on the tables have been raised three inches (11" to underside of top) to permit the arms of wheelchairs to roll underneath. The bench on each side has been divided into two segments to permit a wheelchair to sit in the middle between the benches and two other chairs at the ends, giving it an easy capacity of four people sitting on the benches and one in wheelchairs. In addition, a large concrete slab has been poured around each table to permit room for traffic by handicapped users in wheelchairs, crutches, or those with poor coordination.

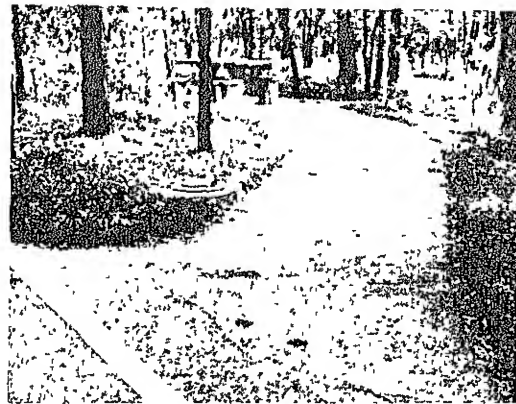
The trail system has been designed with a maximum grade of 5 percent. Grass shoulders along the trail have been designed to slow down the (runaway) wheelchair and also provide a soft landing free of obstructions if the chair should turn over. Handicapped organizations were emphatic in their request that no handrails be used on trails so that the users would have a feeling of freedom of barriers.

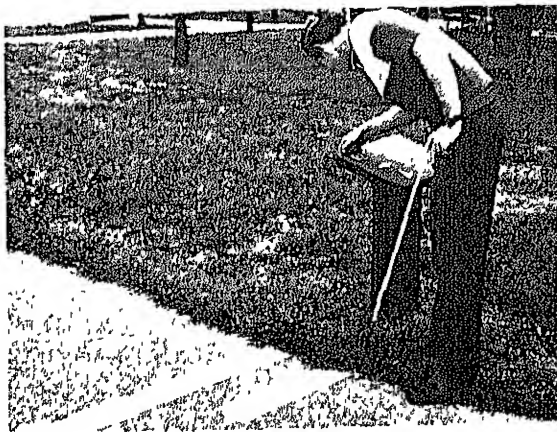
A system of yellow plastic strips about 1/8 inch thick and 6 inches wide has been applied to the pavement to serve as a guide for the totally blind. The strips are readily discernible by the blind individual's cane or foot, but create no barrier to other users such as wheelchairs. Symbols have been developed for use throughout the area. The blind normally guide themselves by tapping first on the pavement and then on the grass shoulder. Two short strips of plastic placed perpendicular to the line of travel indicate a direction sign which can be located by feeling with the right hand adjacent to the trail.

A white line has been painted down the center of the trail for use by the partially or "legally" blind. Many of these individuals can differentiate the black and the white even though they do not have enough vision to know whether a person they are meeting is a man or a woman.

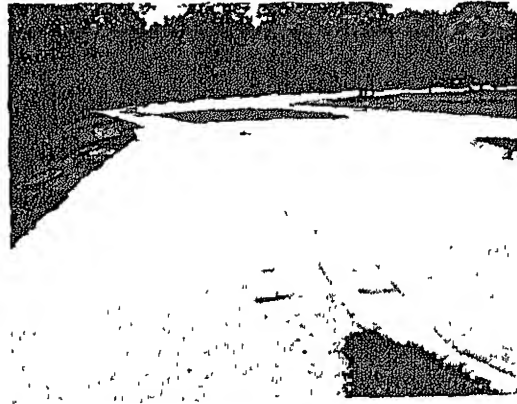
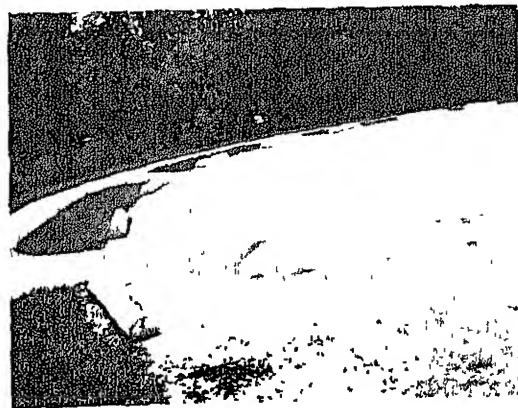
Parking Facilities

The parking lot has been designed to accommodate 33 cars and 3 buses. A bus unloading area has been provided between the parking lot and the bus door. Adjacent to the bus unloading area are asphalt landings sufficient for 25 wheelchair users so that the attendants will have room to unload all of the patients before beginning to distribute the individuals throughout the recreation area.

Individual parking spaces for cars are a minimum of 12 feet wide, permitting ample room for unloading between adjacent cars. No curb is present between the parking spot and the sidewalk that runs the perimeter of the parking lot, so that once in the wheelchair, the person is free to move on his own. In addition, all parking spaces are on the outside of the parking lot so that no one has to cross the center area of the parking lot.

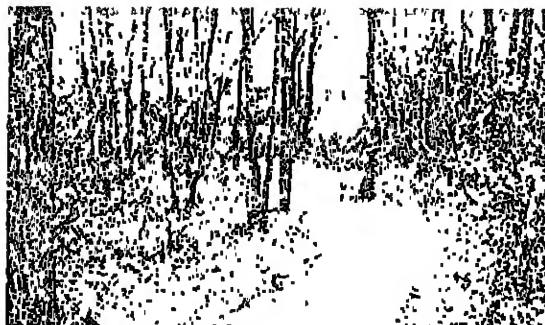
There are two swimming areas on the lake, one next to the day use area and one on the group camp side of the lake. The beaches consist of a large sand area with a paved walk on the upper edge of the beach. The walk leads from the bathhouse to the water's edge where it enters the water forming a large arc until it reaches a depth of approximately three feet. Along one side of this path as it enters the water are metal posts spaced at intervals of about five feet. Attached to these posts is a railing. The handicapped individual can grasp this railing and gradually enter the water. This provides support and security as he works himself into the water. This also helps guide the wheelchair user to assure that he stays on the paved surface.

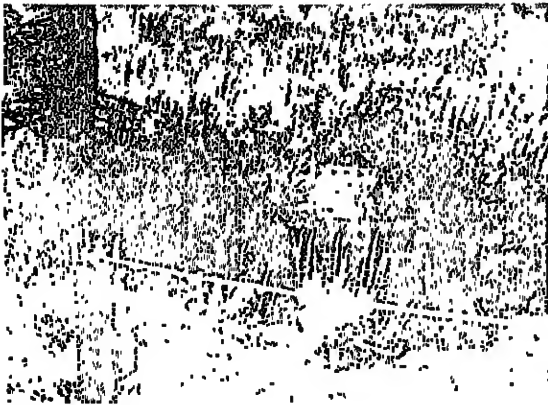
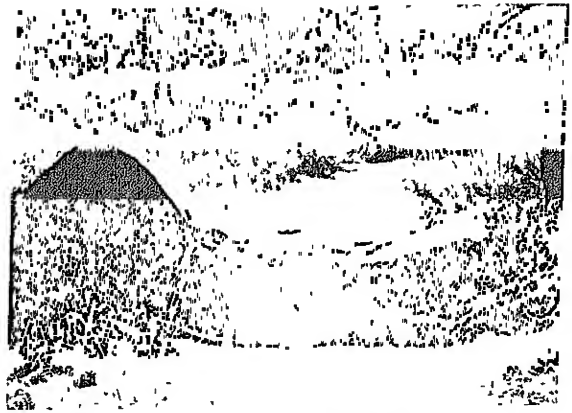
Fishing Pier

Several miles away from the campground at Twin Lakes, a fishing pier and picnic area for the handicapped has been provided. From the parking lot a soil cement path leads to the water's edge and the pier. The pier is constructed of pontoons and wood planking and extends out from the shore approximately fifty feet. A pipe railing extends entirely around the pier, and a straw type matting is secured

to the wood decking. The latter provides a non slip surface when the boards become wet. The end section is about 10 feet wide and 18 feet long, ample room for wheelchair turning. The only problem with this design is the height of the railings. The top rail is about the eye height of a person sitting in a wheelchair. He has to look either over or under the railing

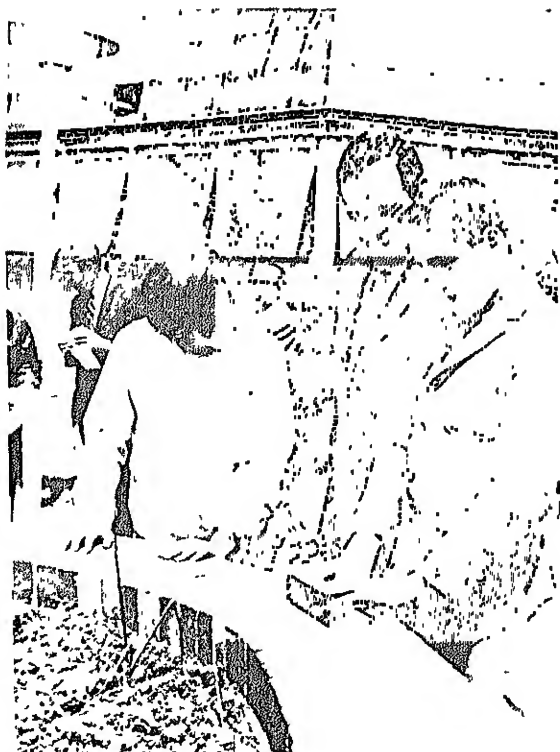
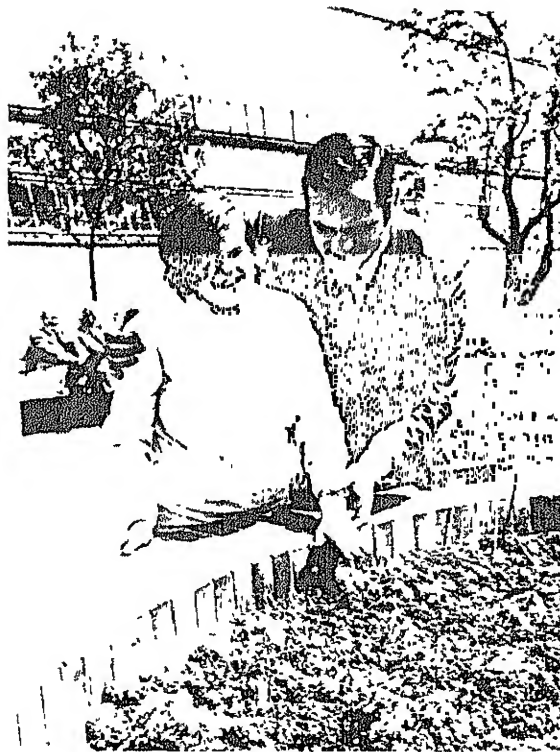
**GARDEN OF FRAGRANCE
STRYBING ARBORETUM
GOLDEN GATE PARK
San Francisco, California**

As one enters this garden of fragrance he is invited to touch, smell or taste the plants that are there. Tucked away in a corner of the Arboretum, the garden goes almost unnoticed by the passing visitor. A 30 inch stone wall salvaged from an old Spanish monastery forms the raised planters of the garden and acts as a guide to the blind.

Mounted on top of the wall are small plaques with braille inscriptions describing the type of plant at that point in the walk. In some areas the plants are hanging over the rock wall so that if a blind person were guiding himself along the wall his fingers would run across these plants or he would brush against them. About 20 plaques along the wall identify specific plants. It is obvious that the visitors take advantage of the closeness of the plants. Around each sign the plant is broken and worn back where it has been touched and pieces broken off.

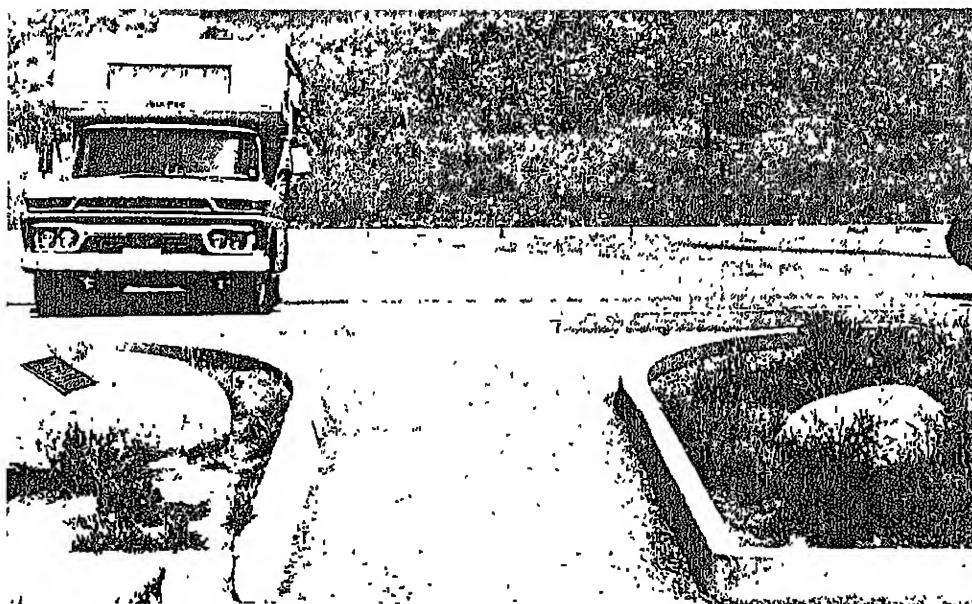
As the visitor reaches the top of the slope, he can easily make his way to the parking lot via an asphalt path between two curbed planting areas. Wide cuts through the wheel stop curb provide easy access to the car for the wheelchair user

The site provided some special problems that have been well-analyzed and solved. Because of the nature of the reservoir, the water level fluctuates greatly over the year, from a high level in the spring to a low level in late summer. Access to the water's edge became a difficult problem. To solve this, the fishing pier was constructed approximately twenty feet out in the water. A bulkhead was built and then filled in behind and covered with a concrete slab used as the surface for wheelchairs.
